**Professional Analysis
and Consulting, Inc.**

Project No. 2068

ELVIS RAMÓN GREEN BERRÍOS

SIG SAUER, INC.

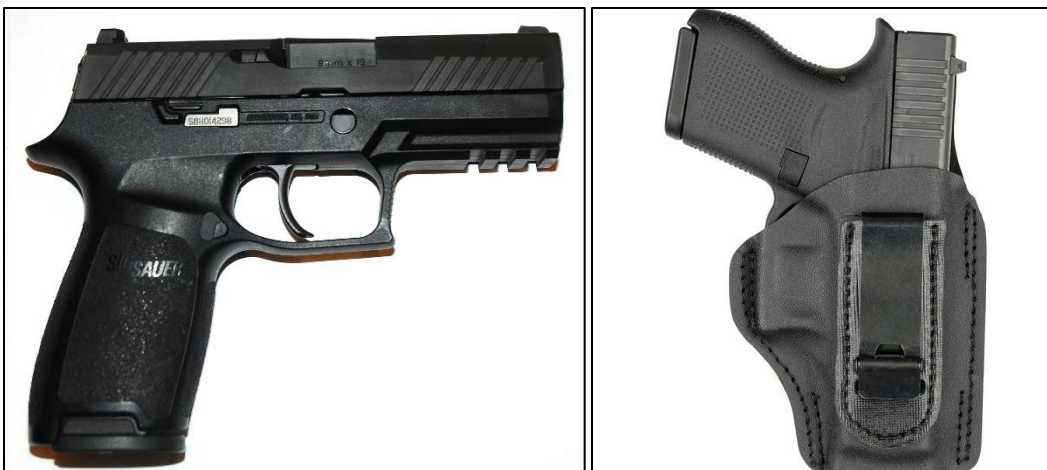
Figure 1 - Subject Sig Sauer P320 (left), exemplar Safariland P320 IWB holster (right)

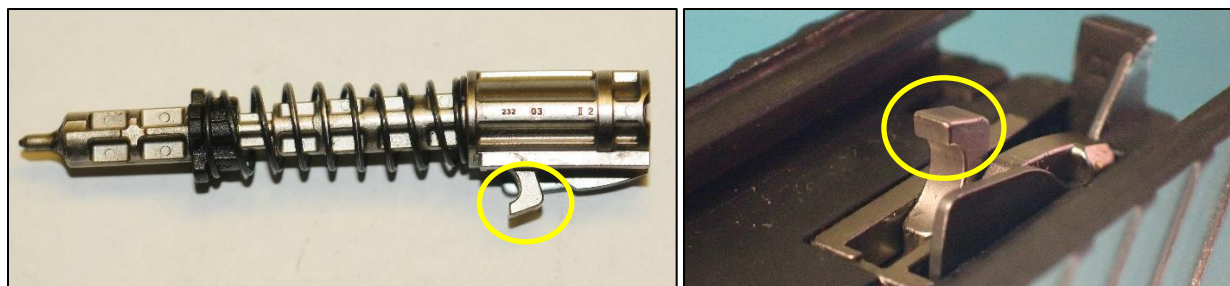
1. The sear and striker pin components, the engagement of which is a critical feature of this design, are produced using a Metal Injection Molding (MIM) process and do not have any secondary machining performed on the small engagement surfaces. These MIM-produced components have areas of excessive variability due to the manufacturing process. For surfaces where tight tolerances and consistent fit-up are required, MIM parts will typically have secondary processing, or machining, to eliminate the processing variation. See Figures 2 – 3.

Figure 2 - Striker assembly with striker foot circled (left), striker assembly in the slide assembly (right)

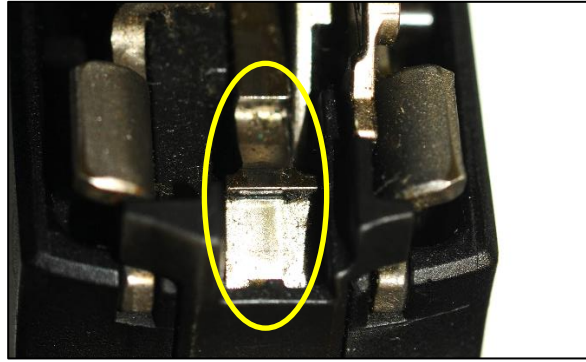
Figure 3 - Top rear view of sear (circled) and off-center striker drag marks

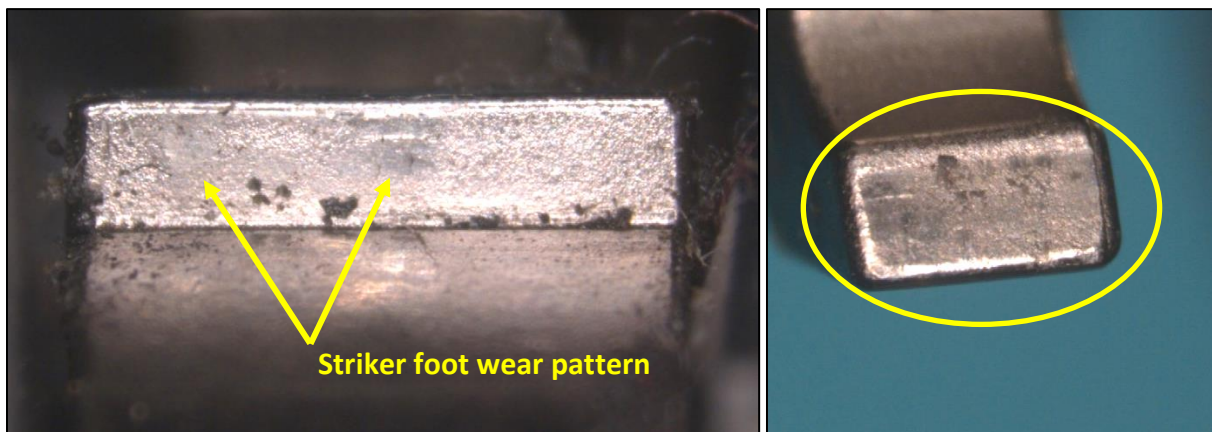
2. The sear and striker foot portion of the striker pin both exhibited inconsistencies on the surfaces that are in contact with each other, minimizing the actual contact surface area that is needed to keep the parts engaged until the trigger is pulled. In addition to the MIM as-manufactured surfaces (rough and unmachined), both parts also exhibited a raised area around the periphery of the interface surface and large radii on the critical edges. The end result is reduced contact surface area between both components, making the firearm more susceptible to un-commanded discharge. Figure 4 (left) is a close-up photograph of the sear step with clear wear pattern from the striker foot that shows an inconsistent pattern, including an area within the step with no wear. Figure 4 (right) is a close-up photograph of the subject striker foot showing the raised area around the periphery of the face, radiused edges, and an unmachined surface.

Figure 4 - Close ups of sear step (left), and striker foot (right), both unmachined surfaces

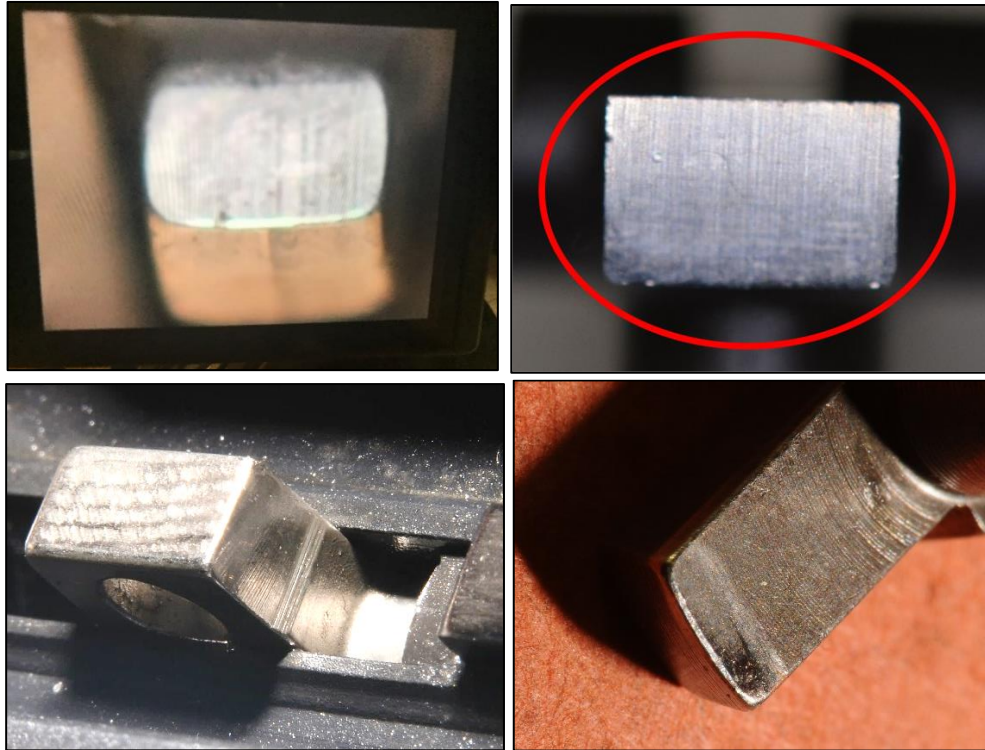
3. In comparison, the photographs in Figure 5 show the machined (or some other secondary processing after molding) surface of the striker foot and sear from other manufacturers' firearms. The photo on the bottom left is from the writer's Springfield Armory XD's striker fired firearm, which has both a tabbed trigger safety and grip safety. As discussed below, the CT scan is unable to be utilized in quantifying or measuring the inconsistencies of the surfaces of the striker foot face or the sear step face due to its limited resolution. However, feature size and dimensions, including radiused corners and edges, can be measured from a CT scan, described throughout this report.

Figure 5 - Other firearms - striker foot (top left), sear face (top right), striker foot (lower left), and striker foot (lower right) all with machined flat surfaces

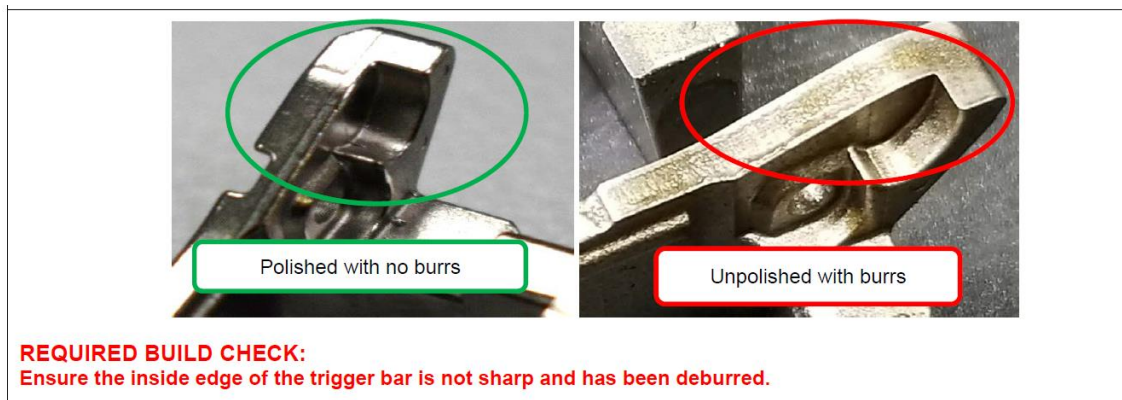
Additionally, the Sig Sauer Quality Control Document⁵ specifies that the trigger bar needs to be “*polished with no burrs*” but does not specify the same requirement for the sear or the striker pin. Sig Sauer recognizes the need to perform secondary processing on some parts of the P320 but chose not to do so on the sear or the striker pin. See Figure 6.

Figure 6 - Image from Sig Sauer P320 Assembly and Quality Inspection Master

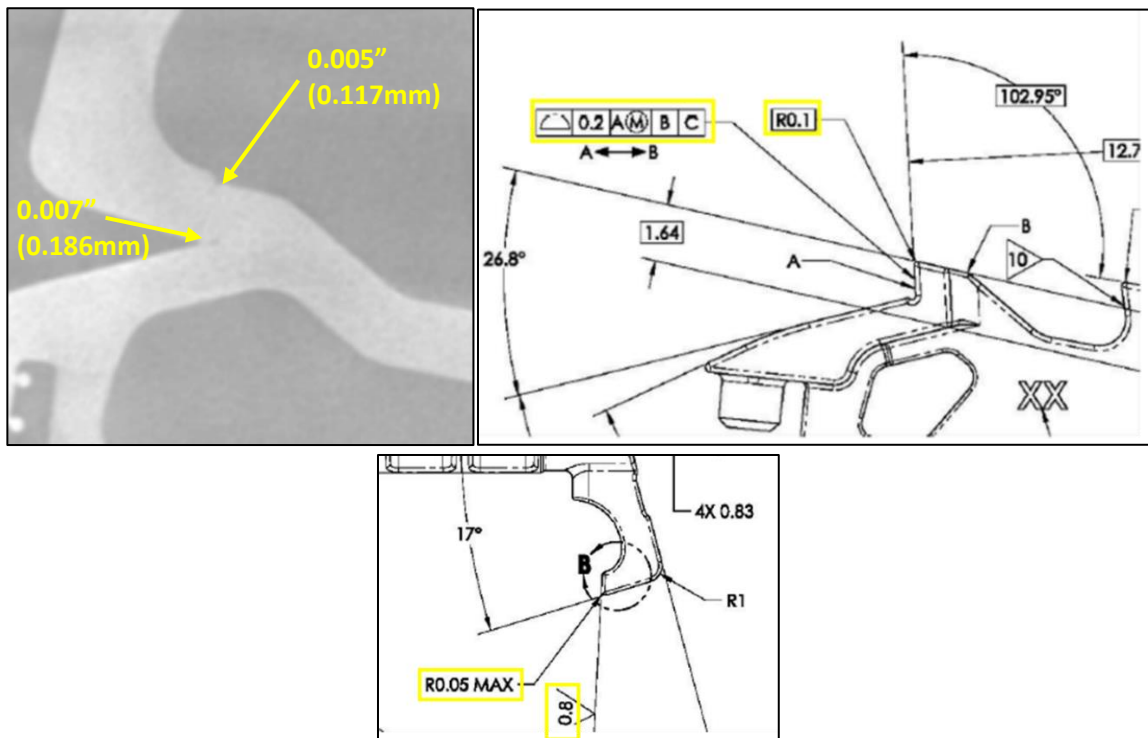
4. The CT scan was also used to document the striker and sear engagement areas as compared to the drawings, shown in Figure 7. The sear step had the top surface, where the striker foot is released from,

measured radius at 0.005" (0.117 mm), with the Sig Sauer drawing #1302192⁶ indicating a radius of 0.1 mm. The surface profile where the striker engages indicates a tolerance of 0.2 mm, but as with the other components discussed in this report, this dimension could not be quantified with the CT scan. The Sig Sauer striker drawing #1302193⁷ indicates the radius on the bottom edge of the striker foot at 0.002" (0.05 mm). The CT scan of the bottom edge of the striker foot radius measured 0.007" (0.181 mm), larger than the specification. This drawing also indicates that the surface that engages with the sear step has a surface finish specification of 0.8, but this could not be quantified with the CT scan. Based on exemplar firearm measurements, where the surface finish was measured to be rougher than the specification, it does not appear that the subject striker foot would meet the surface finish requirement.

Figure 7 - CT scan of the subject striker and sear (top left), sear drawing (top right), and striker drawing (bottom)

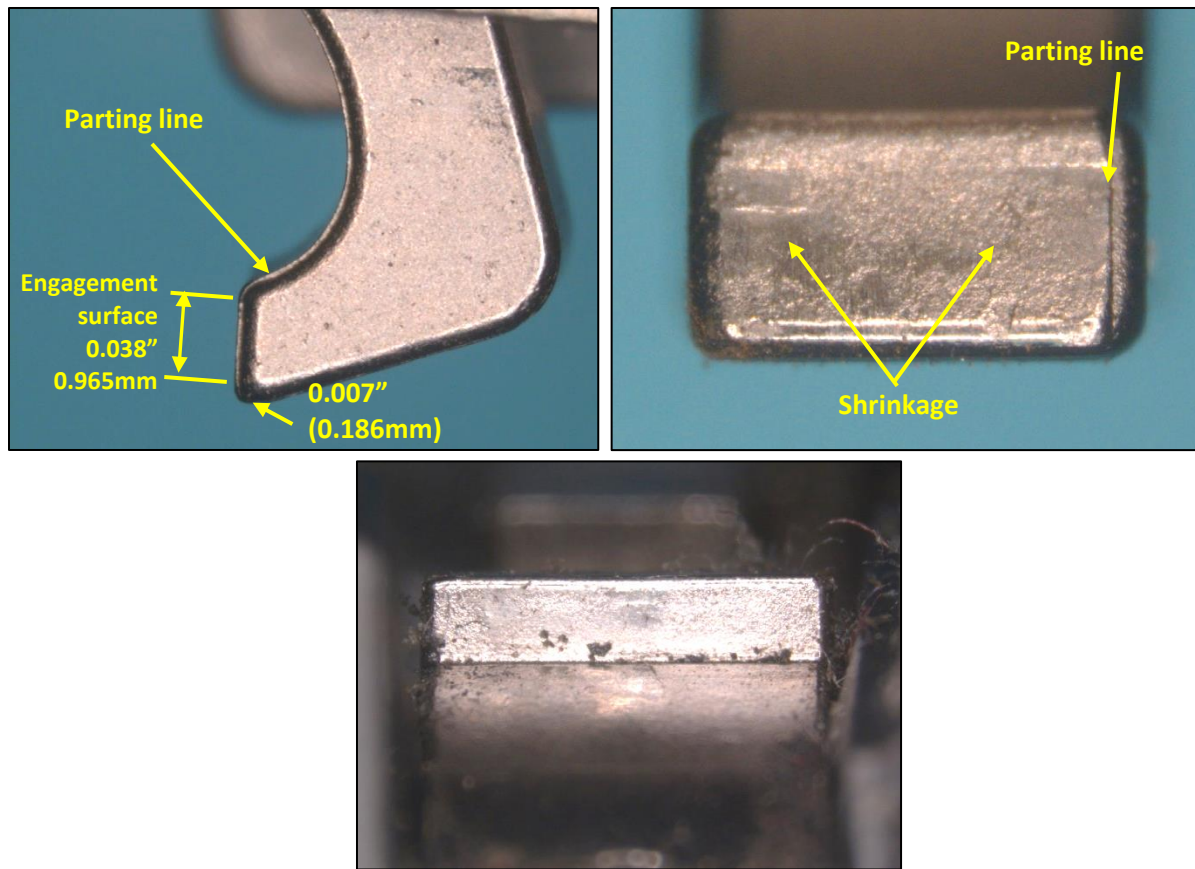
The striker and sear were also documented using a stereomicroscope. The images shown in Figure 8 further document the striker foot manufacturing defect issues (rough surface finish, raised outer perimeter, large radiused edges, and a parting line). The sear step had a rough surface finish and radiused edges beyond specification.

Figure 8 - Striker foot area (upper left and right), Sear with rough surface and radiused edges (lower)

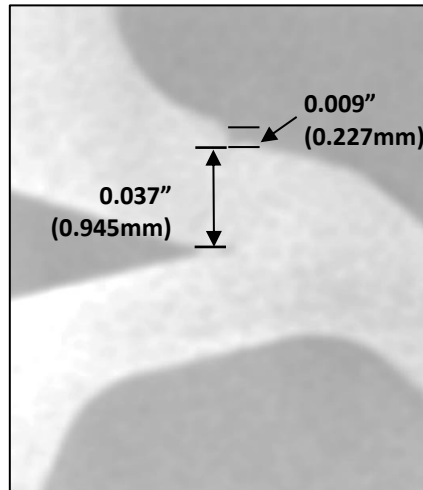
5. In addition to the lack of secondary processing on the sear and striker foot, there is also a vertical misalignment of the two parts, as shown in the CT scan in Figure 9. The striker foot is unable to fully engage with the sear face surface, limiting the area available for the engagement of the two parts. With the minimal amount of overlap and engagement between the two components, a minor amount of vibration, shock, or relative movement between the slide and the grip module would allow the striker to no longer be retained by the sear, and to move forward and discharge a round. In other words, the ongoing relative movement between the slide and the grip module, in addition to the inertia and vibration experienced while secured in a Sig Sauer authorized holster over time, will allow the striker foot to become disconnected from the sear face, in combination with the other defects identified in this report, including parts not meeting drawing specification. For reference, the contact surface area measured 0.038" (0.965 mm). No documentation has been produced by Sig Sauer that identified what the design specification is for the contact surface area between the striker foot and the sear. An additional 0.009" (0.227 mm) is available on the striker foot for engagement with the sear, if the sear step was larger, and both striker and sear were machined to eliminate the radiused edges, in order for the components parts to meet the drawing specifications.

Figure 9 - Subject striker foot to sear contact surface and vertical offset

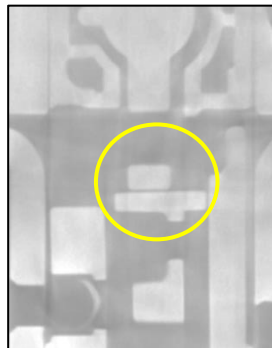
6. As shown in the CT scan below, there is also a lateral offset between the sear and the striker, causing an unbalanced force and off-center contact on the sear. This off-center contact between the two components allows the sear to be loaded laterally, causing the striker foot to make more contact on one side versus the other. When the sear is consistently loaded in one direction due to the misalignment, it contributes to reducing the actual contact surface area between the striker foot and the step in the sear. The CT scan of this offset is shown in Figure 10. Figures 3 and 4 above show the off-center and inconsistent contact area from the striker foot on the sear step.

Figure 10 – CT scan slice of striker foot offset to sear

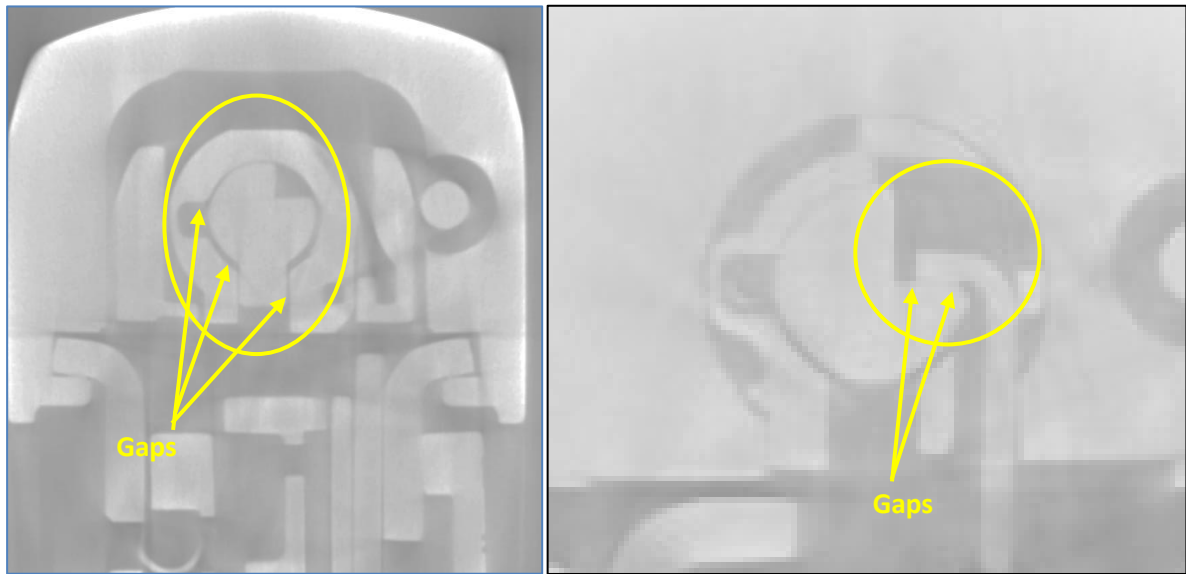
7. In looking at the rear-view CT scan slices of the striker pin relative to the housing, there are gaps within the striker housing, as shown in Figure 11 (left within yellow circle). This allows for axial rotation and movement of the striker pin within the housing each time the firearm is discharged and the slide cycles. This movement will also cause the safety lock tab that is intended to make contact with the parallel horizontal plane of the striker (striker channel) to become out of alignment, and not parallel, creating a gap. Based on the component drawings supplied by Sig Sauer, the maximum allowable angle of the striker pin to the housing is nearly 4°, however, Sig Sauer has not produced any assembly drawings that document the specification tolerances of the complete striker assembly. The misalignment and rotation will cause minimal contact between the safety lock tab and the rear vertical stop portion of the striker, thereby reducing the contact area between the two surfaces. The misalignment contributes to allowing the striker

pin to continue its forward movement when the striker foot is no longer retained by the sear, in combination with the other defects identified in this report, leading to an un-commanded discharge. The misalignment of the safety lock tab to the striker pin is also shown in Figure 11 (right).

Figure 11 – CT scan view from the rear of striker gaps to housing (left) and safety lock tab misalignment to striker pin (right)

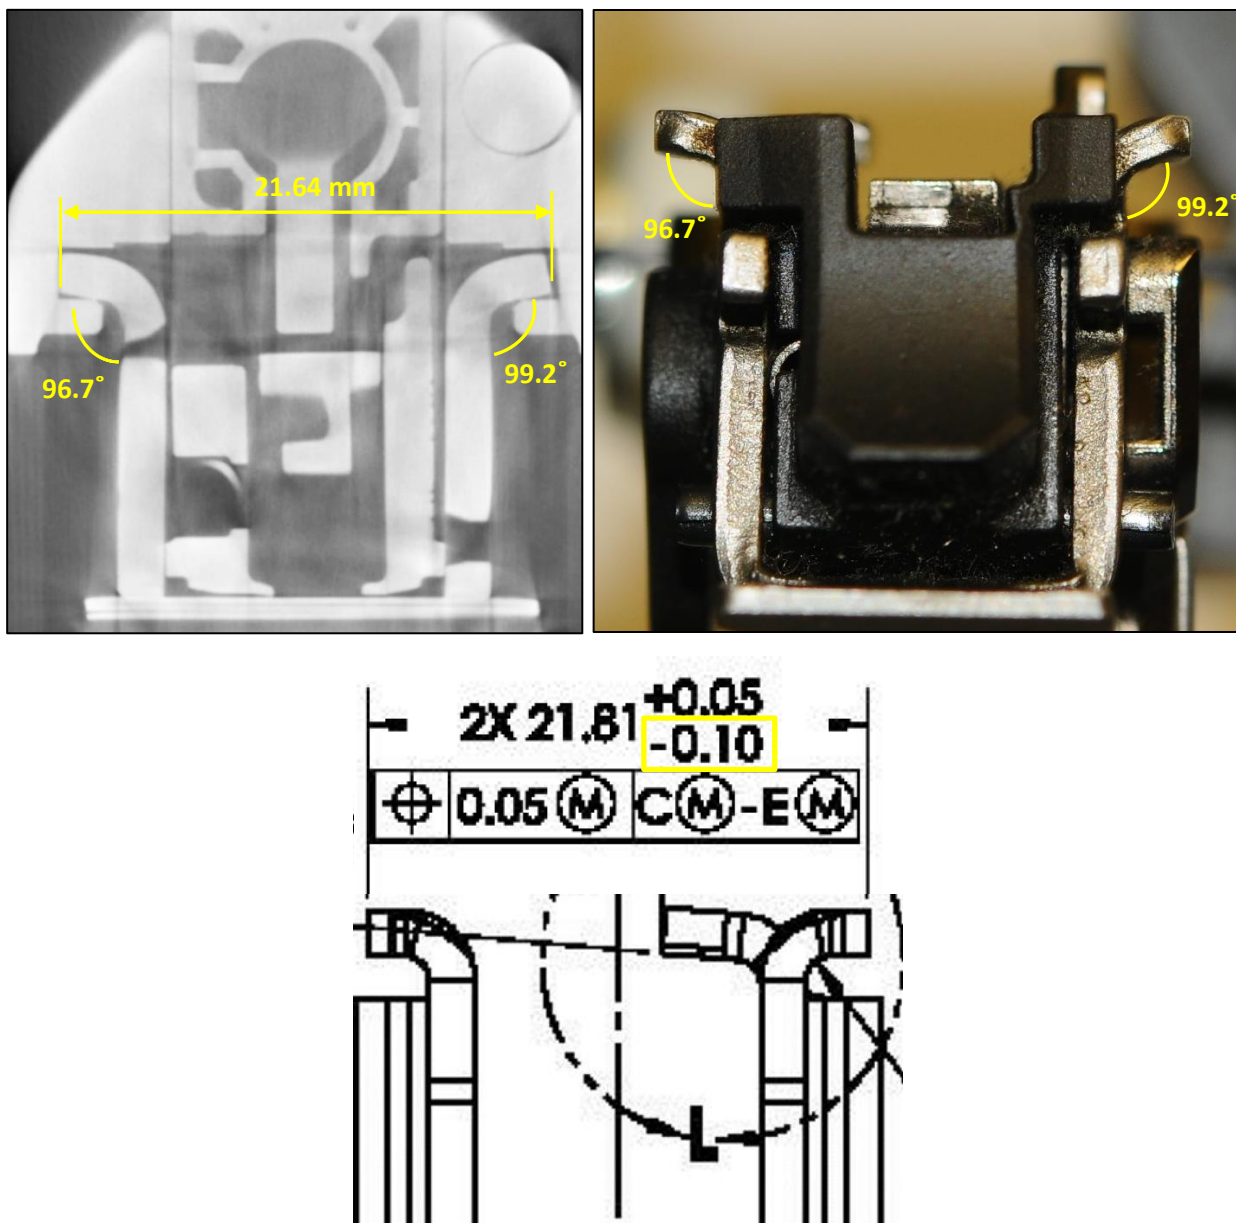
8. The CT image and photograph shown in Figure 12 illustrate the slide assembly gaps to the grip module. These gaps allow the striker foot (as part of the slide assembly) to move vertically and laterally relative to the sear (in grip module) with any vertical and lateral movement, such as that experienced while the firearm is carried in a holster, and with vibration and inertial forces. The frame receiver stamping is not made to specification which contributes to the variation and fitment issues between the slide assembly and the grip module. The horizontal tabs were measured at 96.7° and 99.2° from the vertical wall, when the drawing specification indicates 90°. Also, the overall width between the slide tabs measured 21.64 mm, smaller than the 21.71 mm minimum tolerance shown on the drawing. A digital caliper was also used to measure the width of the slide tabs, measuring 21.62 mm (rear) and 21.52 mm (front).

Figure 12 – CT scan showing receiver frame distortion (upper left), photograph of the same area (upper right), and image from Sig Sauer drawing #1301552

The frame receiver stamping drawing image is also shown in Figure 12 (bottom). The bottom surface of the receiver tabs are shown as datum “Z” on the Sig Sauer drawing 1301552⁸ and all four tabs have a GD&T⁹ callout specifying flatness as 0.1 mm. Since none of the four tabs on the frame receiver stamping are perpendicular or flat relative to datum “Z”, the frame receiver component does not meet the drawing specification. The bottom surface of the tabs also shows an inconsistent surface due to the forming process, providing for additional variation between the slide and grip module.

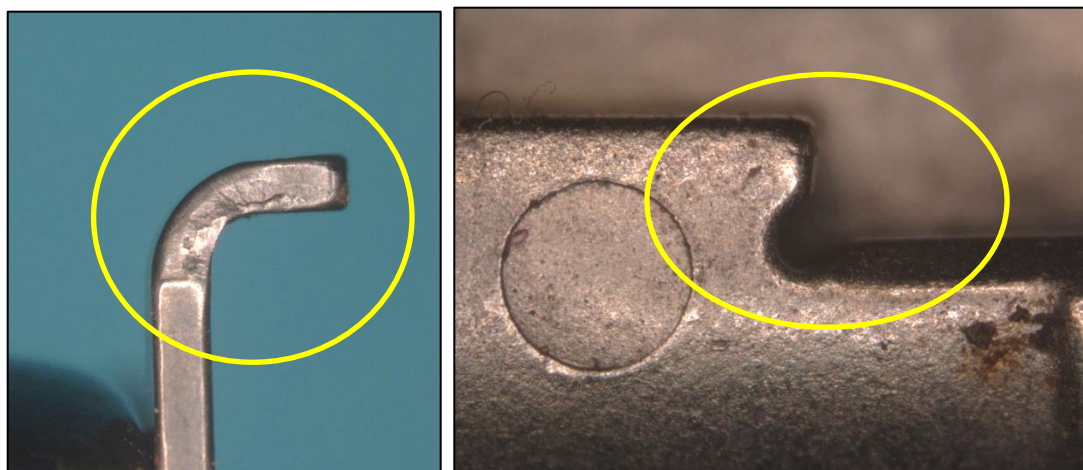
9. In addition to the issue related to the lack of the safety lever return spring, as well as the misalignment of the safety lock and the striker components, there were also issues noted with the safety lock and the striker stop components. The tab portion of the safety lock had an inconsistent surface, due to being a stamped steel part and unfinished on the area that is intended to engage with the striker stop, shown in Figure 13 (left). Correspondingly, the striker stop surface was rounded and unfinished (MIM), as shown in Figure 13 (right). The combination of these two poorly manufactured surfaces would allow the striker to not be restrained by the safety lock, if the striker becomes disconnected from the sear, allowing an un-commanded discharge.

Figure 13 – Subject firearm manufacturing issues with the safety lock tab (left) and the striker stop (right)

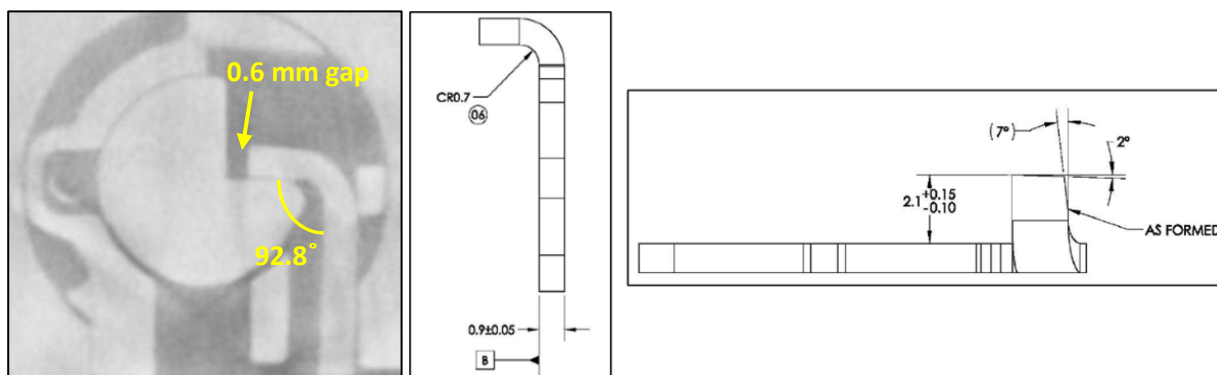
Additionally, the CT scan and stereomicroscope were utilized to quantify certain safety lock and striker stop measurements. Figure 14 shows the CT scan measurements for the safety lock (left) and the corresponding area from the Sig Sauer drawing #1301029¹⁰ (center and right), which show the safety lock tab is not formed properly at 92.8°, with the drawing indicating 90°. The profile of the surface shown in Figure 13 (left) of the safety lock tab example, that is intended to come into contact with the striker stop, has a tolerance specified as .008" (0.2 mm). The actual surface quality could not be measured with the CT scan, but it does not appear to visually meet the drawing specification.

Figure 14 – Safety lock image from CT scan (left), and images from Sig Sauer drawing of safety lock (center and right)

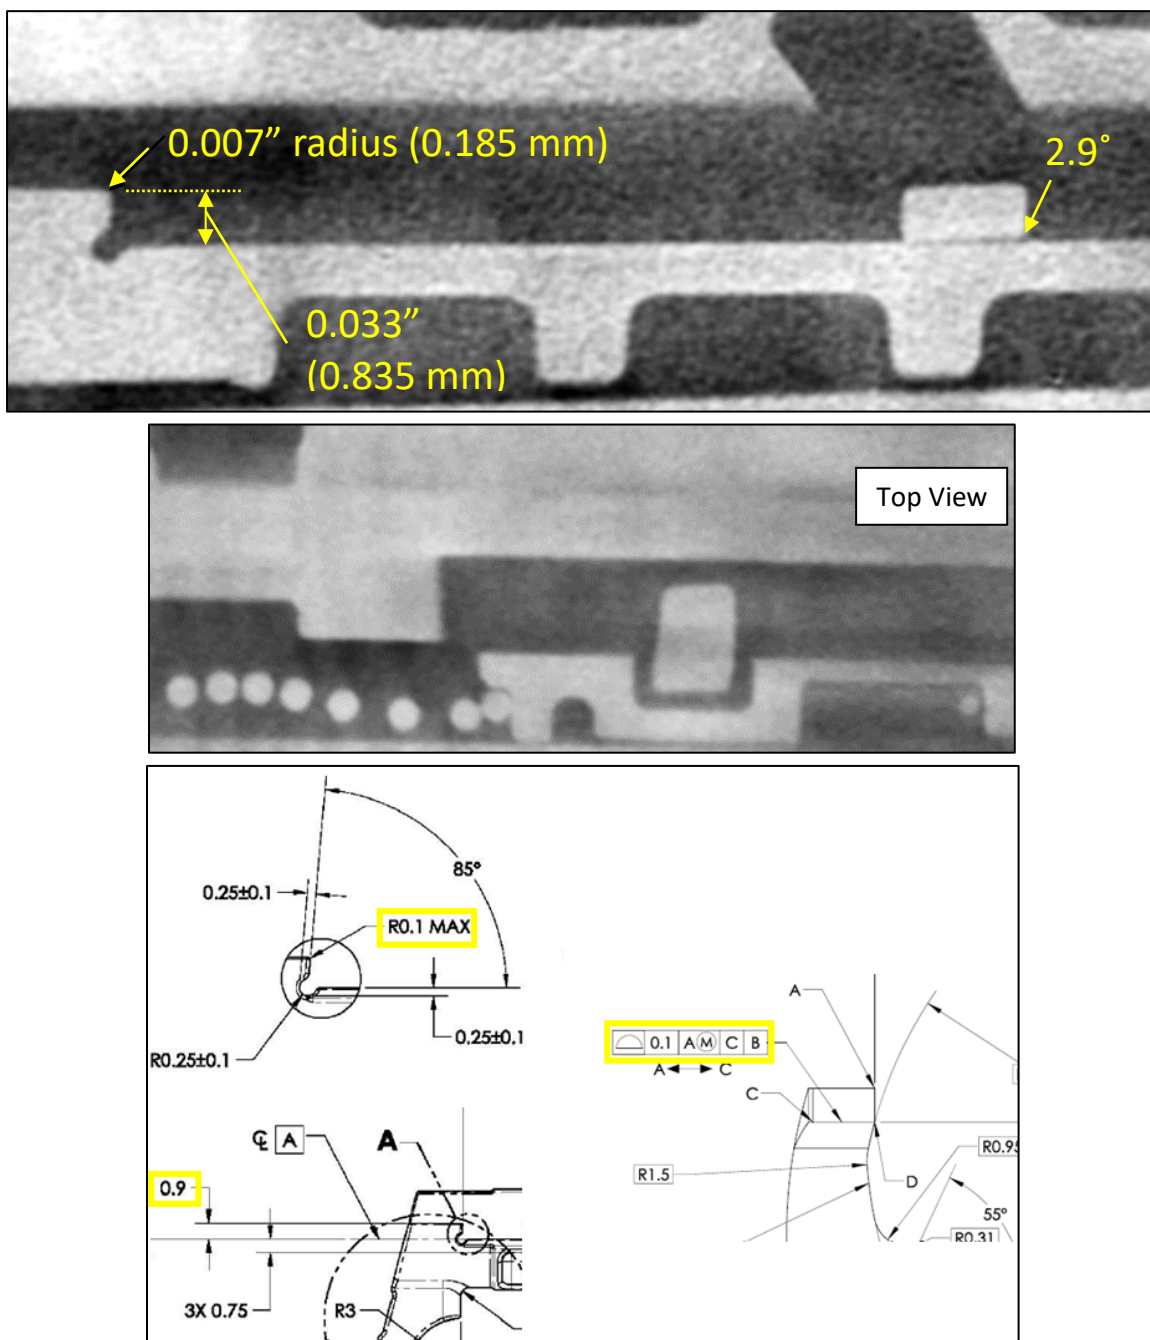
The CT scan was also used to measure and quantify the safety lock and striker stop from a side view. Figure 15 shows the CT scan measurements for the striker stop and safety lock (top and center) and the corresponding area from the Sig Sauer drawings (bottom). These images show the safety lock tab is not formed properly since the 2.9° gap is beyond the surface profile designation on the Sig Sauer drawing¹¹ of 0.004" (0.1 mm). The striker stop has a 0.007" (0.183 mm) radius profile and is 0.033" (0.835 mm) high, compared to 0.004" (0.1 mm) and 0.035" (0.9 mm) respectively, from the Sig Sauer drawing #1302193,¹² shown in Figure 15 (bottom).

Figure 15 – CT scan of striker stop and safety lock (top), top views of same parts (center), Sig Sauer drawings of the same parts (below)

Since the thickness of the safety lock is specified as 0.035" (0.9 mm), the combination of the quality issues discussed above, misalignment of the striker and safety lock, and possible contact from the safety lever (since the return spring has been eliminated), means that with less than 0.040" (1 mm)¹³ of displacement or movement, the safety lock will not be in a position to stop the striker from moving forward if the striker becomes displaced from the sear without the user pulling the trigger. This also assumes that the parts

are made to the drawing specification, which they are not, in the subject firearm. The out of specification items described with the safety lock and the striker stop reduces the amount of displacement required to cause the safety lock to fail to stop the striker from contacting the cartridge.

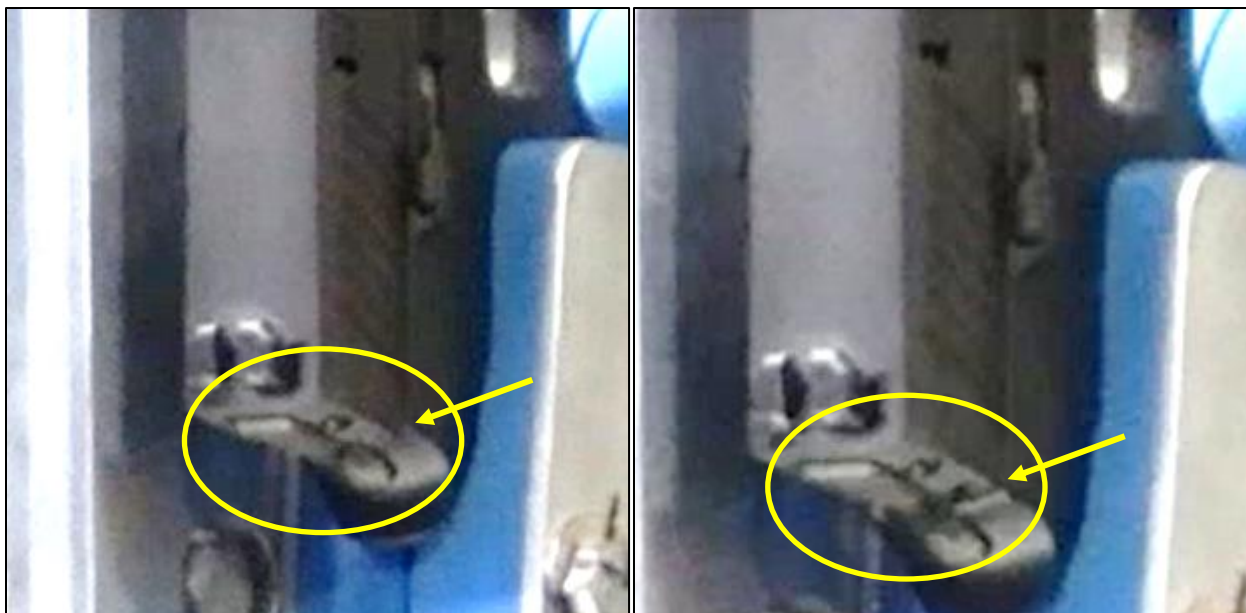
The first tests performed were the vibration tests, which included sinusoidal vibration at various frequencies, and shock (jolt) testing. While the summary report from the testing facility states that no primers were struck, there were several instances of significant movement between the slide assembly and the grip module, with a couple of examples shown in Figures 16 and 17.

Figure 16 – Sig Sauer Vibration #1 Test #3 Showing slide moving relative to grip module

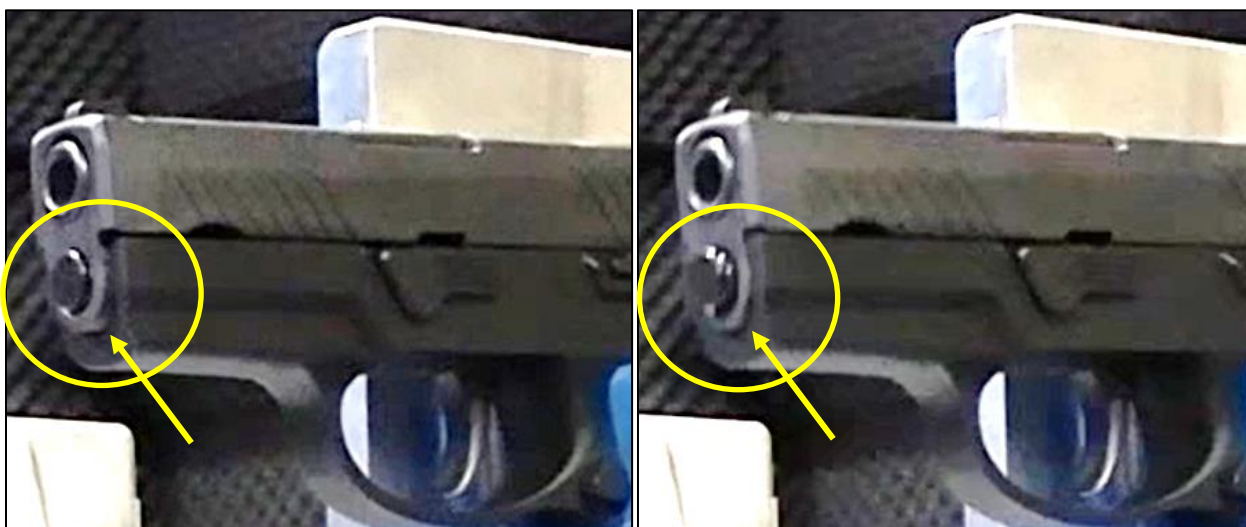
Figure 17 - Sig Sauer Vibration #2 Test #2 Showing slide movement relative to the grip module

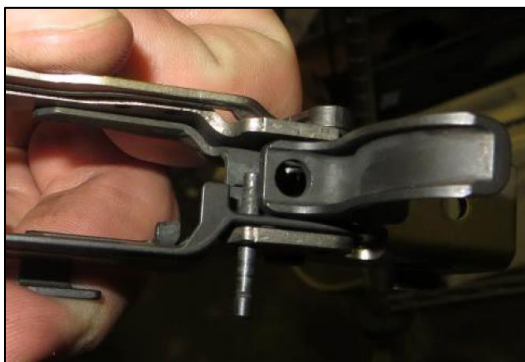
Additionally, the vibration test #1, iteration #3 had a trigger stop pin become displaced, as shown in Figure 18.

Figure 18 - Vibration Test #1 Iteration #3 Photo #66 showing trigger stop pin displaced
